2008 Pontiac G8 | G8 Service Manual | Safety and Security | Supplemental Inflatable Restraints | Repair Instructions |

## **Lumbar Support Knob Replacement**

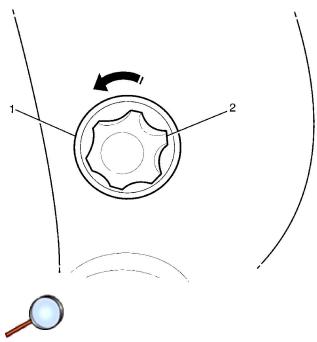
- 1. Turn the lumbar support adjuster deflector ring (1) anti-clockwise until it is released from the adjuster shaft.
- 2. Remove the deflector ring (1) and knob assembly (2) by firmly pulling forward.

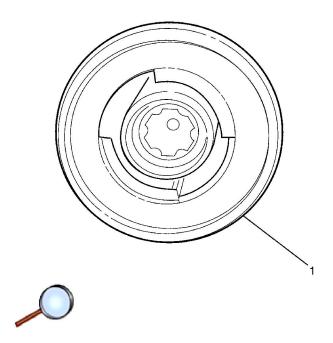
**Important:** Ensure the adjustment shaft is engaged in the sleeve.

1. Install the deflector ring (1) onto the adjustment shaft.

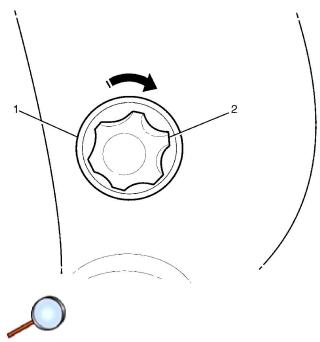
- 2. Twist the lumbar support deflector ring (1) clockwise until it locks into place on the adjustment shaft, listen for an audible click to confirm fitting.
- 3. Install the lumbar support knob assembly (2) by firmly pushing it onto the adjuster shaft.
- 4. Test lumbar support assembly for correct operation.
