2009 Pontiac G8 | G8 Service Manual | Transmission | Automatic Transmission - 6L50/6L80/6L90 | Repair Instructions - On Vehicle | Document ID: 2101859

Control Valve Lower Body and Upper Body Replacement

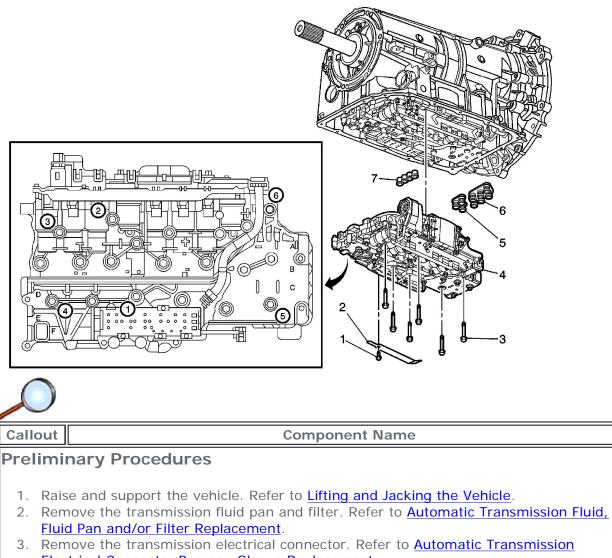
Manual Shaft Detent Bolt
1	Caution: Refer to Fastener Caution in the Preface section.
	Tighten 12 N⋅m (106 lb in)
2	Manual Shaft Detent Assembly
	Control Valve Assembly Bolt (Qty: 6)
	Tip Do not remove all the bolts in the control valve body assembly. Remove only the bolts indicated. © 2013 General Motors Corporation. All rights reserved.

Tighten in specified sequence.
3	Tighten
	8 N·m (71 lb in)
4	Control Valve Assembly
5	Fluid Pump Seal
	Discard seal and replace with new.
	Fluid Pump Seal
6	Discard seal and replace with new.
	Centre Support Fluid Passage Seal
7	Discard seal and replace with new.
