2009 Pontiac G8 | G8 Service Manual | Transmission | Automatic Transmission - 6L50/6L80/6L90 | Repair Instructions - Off Vehicle | Document ID: 2074478

Torque Converter Housing with Fluid Pump Installation

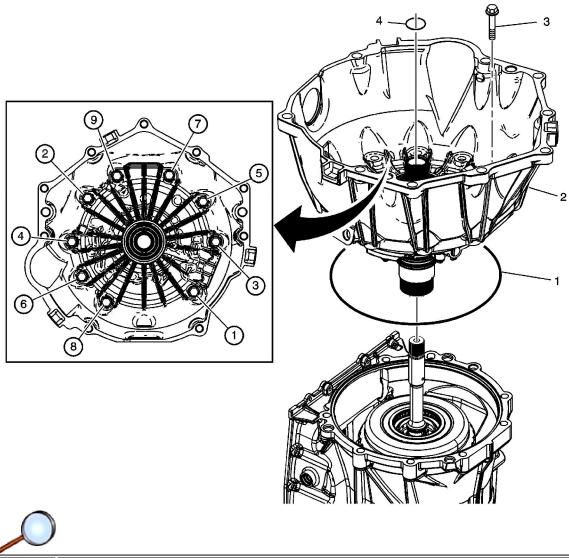
Callout	Component Name
1	NEW Fluid Pump Seal
	Torque Converter (with Fluid Pump) Housing Assembly
	Caution: Ensure the turbine shaft (O-ring) seal is not installed prior to installing the torque converter housing assembly. The seal may become cut or damaged during installation of the torque converter housing assembly.
3	Bolts M10 x 50 (Qty: 9) Caution: Refer to <u>Fastener Caution</u> in the Preface section.
	Procedure © 2013 General Motors Corporation. All rights reserved.

Tighten in the sequence shown.	
	Tighten 72 N·m (53 lb ft)	
4	NEW Turbine Shaft (O-Ring) Seal
