2009 Pontiac G8 | G8 Service Manual | Transmission | Automatic Transmission - 6L50/6L80/6L90 |

Repair Instructions - Off Vehicle | Document ID: 2074373

4-5-6 Clutch Dampener Overhaul

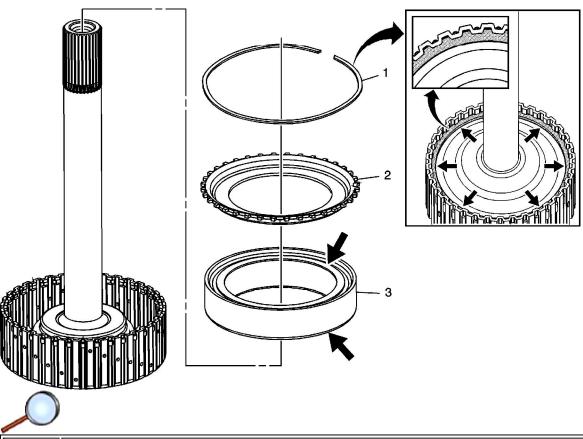
Callout	Component Name
	4-5-6 Clutch Dampener Retaining Ring
1	Caution: Ensure the retaining ring is installed with the tapered side up, and in the 9 o'clock position from the pan side of the case. Failure to properly install the retaining ring will cause transmission damage.
2	4-5-6 Clutch Dampener Apply Plate
3	Tip Dry and inspect the clutch dampener for the following conditions: • Pitting • Flaking • Delamination • Wear • Glazing • Cracking © 2013 General Motors Corporation. All rights reserved.

If any of these conditions are found, replace the dampener.
