2009 Pontiac G8 | G8 Service Manual | Transmission | Automatic Transmission - 6L50/6L80/6L90 |

Torque Converter Housing Cleaning and Inspection

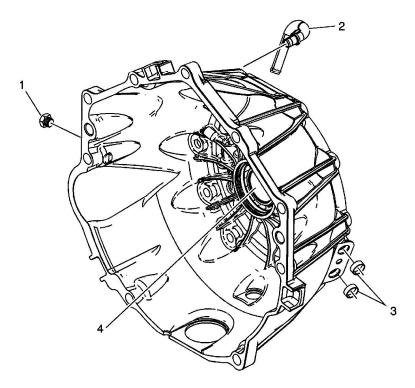
Callout	Component Name
Preliminary Procedures	
so 2. Cl	noroughly clean the torque converter housing assembly, including threads, with clean blvent. lean sealing surfaces. Is necessary, repair any thread damage.
1	Line Pressure Test Hole Plug
2	A/Trans Vent Pipe
3	Trans Fluid Cooler Pipe Fitting Seal Important: Seals must be replaced. Refer to Transmission Fluid Cooler Pipe Seal Replacement.
4	Torque Converter Bushing
