2009 Pontiac G8 | G8 Service Manual | Transmission | Automatic Transmission - 6L50/6L80/6L90 |

Repair Instructions - Off Vehicle | Document ID: 2102319

Control Valve Lower Body Assembly Cleaning and Inspection

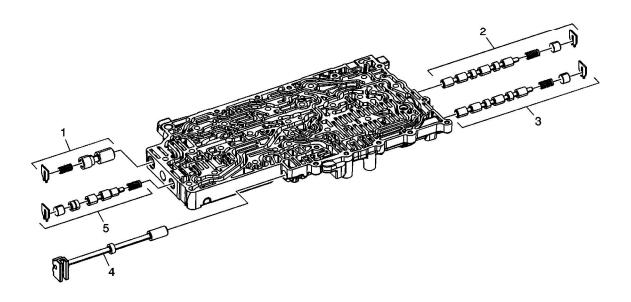
Callout	Component Name
Warning: Valve springs can be tightly compressed. Use care when removing retainers and plugs. Personal injury could result.	
Tip Clean and inspect all valve components and the valve body. The control valve lower body is replaceable only as an assembly.	
1	Clutch Piston Dam Feed Regulator Valve Train
2	Clutch Select Solenoid Valve Train
3	Clutch Select Solenoid Valve Train
4	Manual Valve
5	TCC Regulator Apply Valve Train
